The consequences of operating EWPs on soft ground, inclines and unsupported surfaces.

EWPA

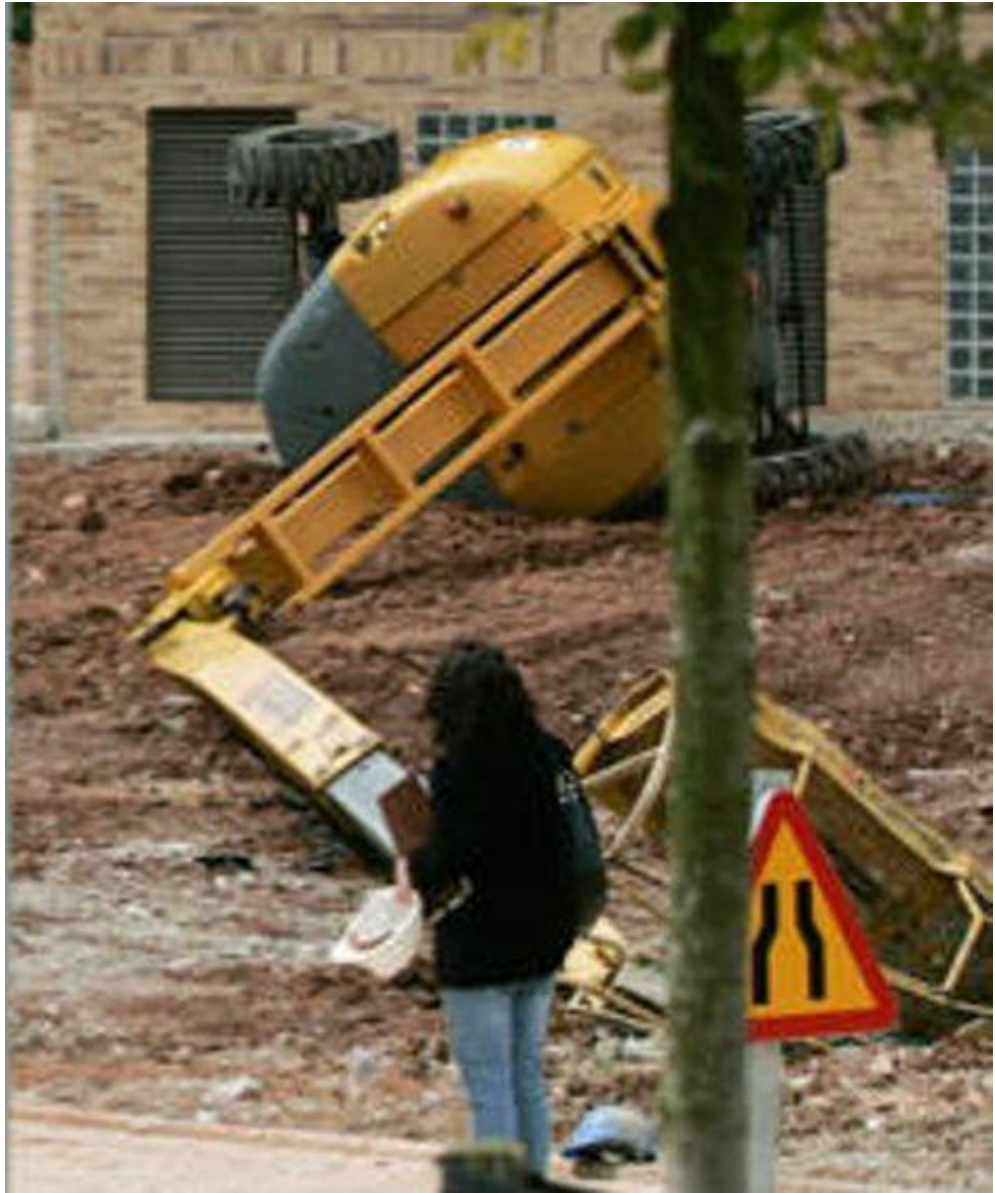
Soft Ground.
Fatality.
Europe.

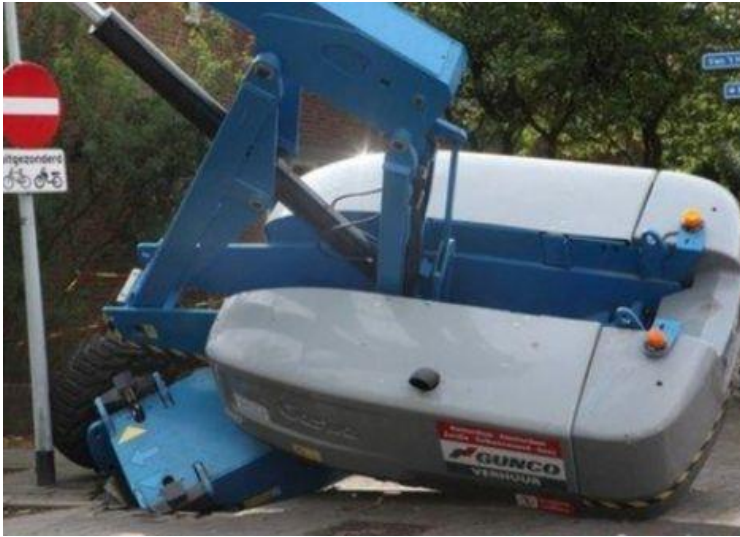
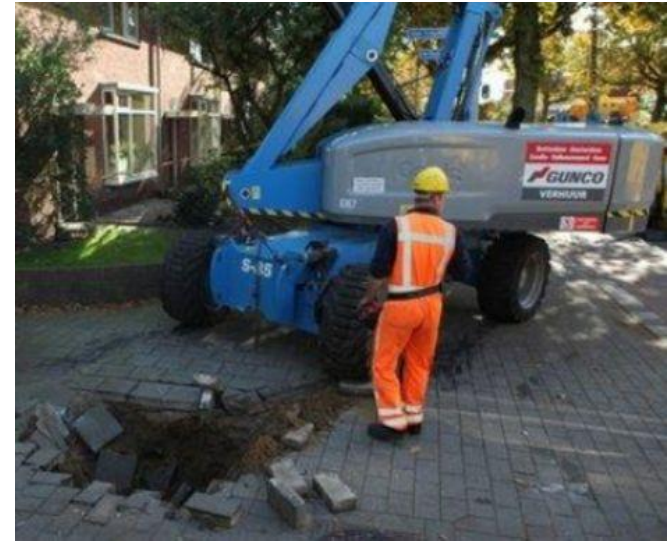
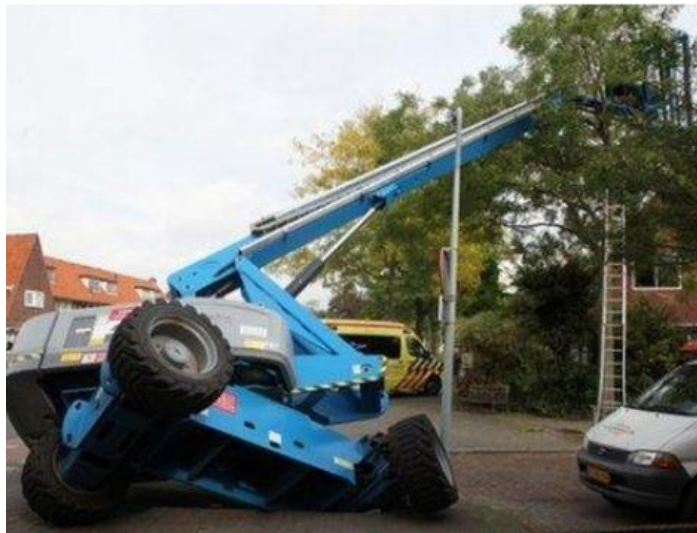
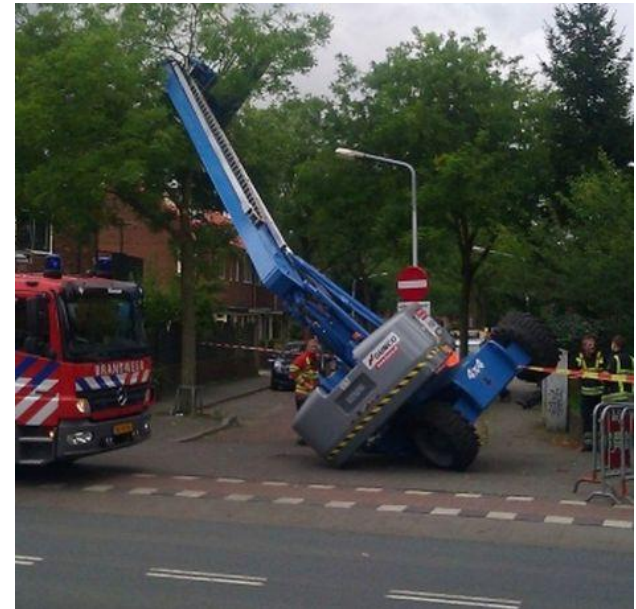
Unsupported surface, Wheel into void. Rescued operator. Europe.

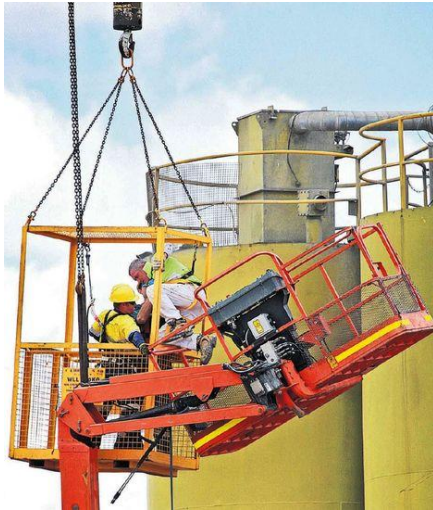
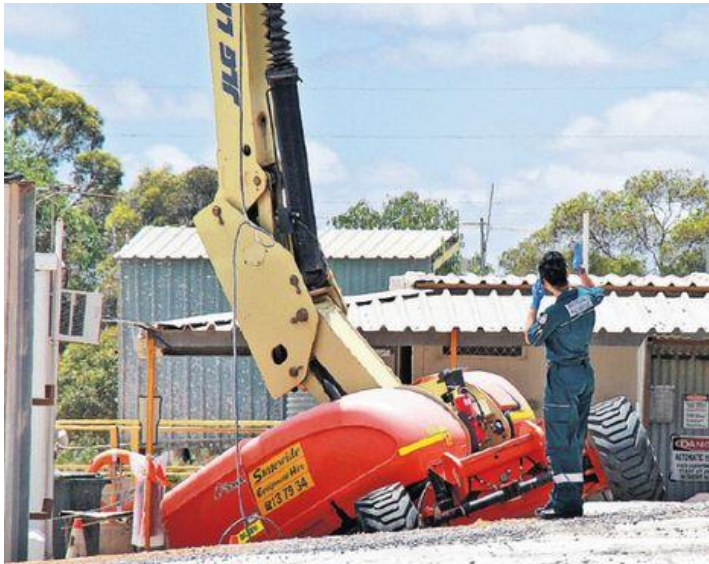
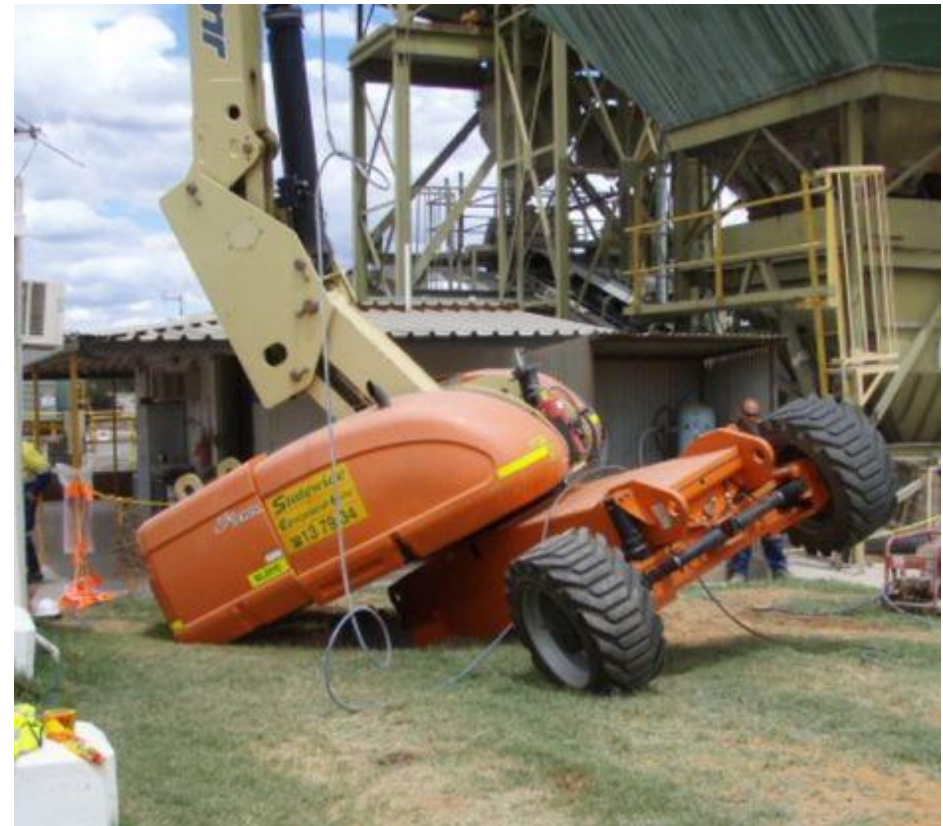
Broke through underground void,
1 fatality from catapult effect, other
operator rescued. Australia.

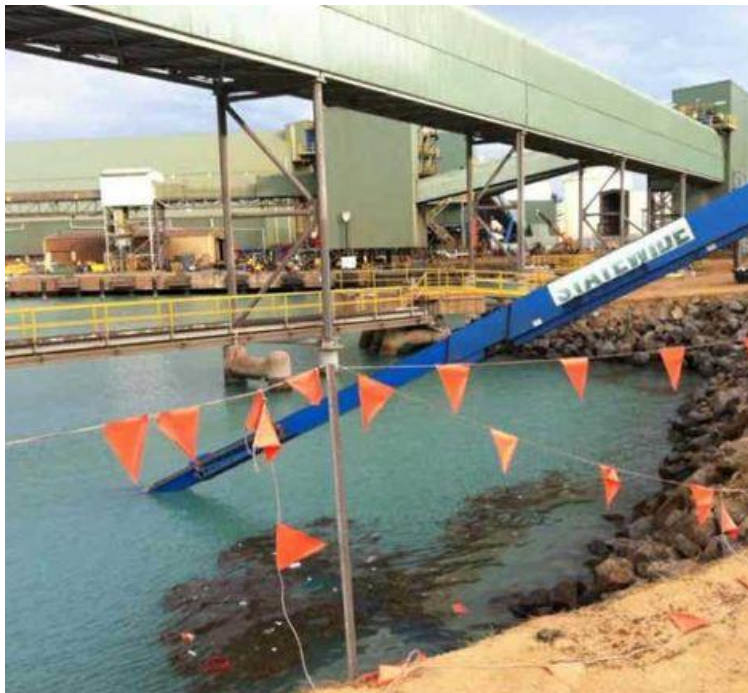
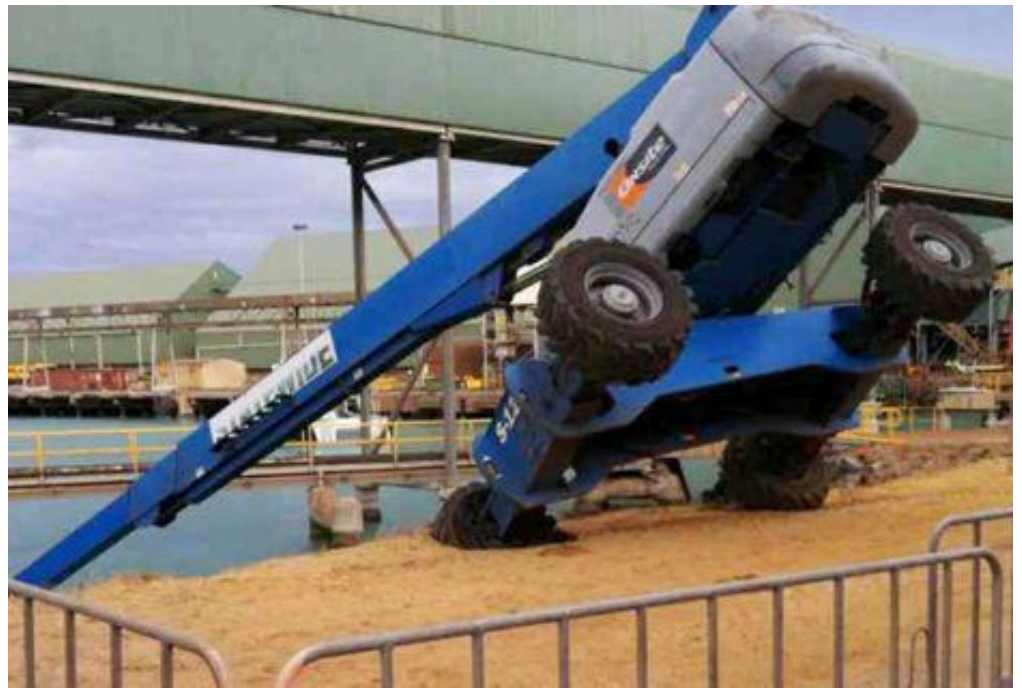
Soft sand unable to support load. Two into the water, Australia.

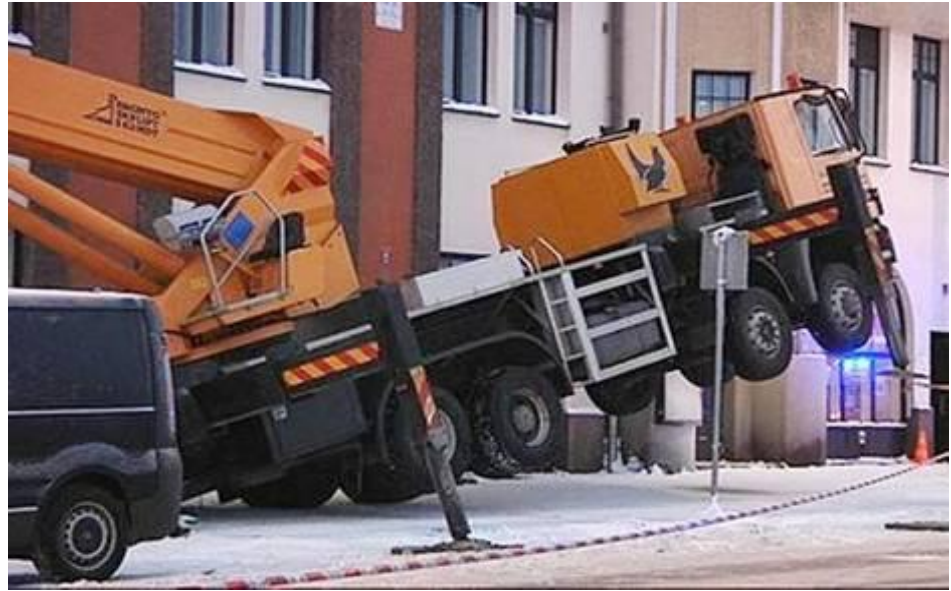
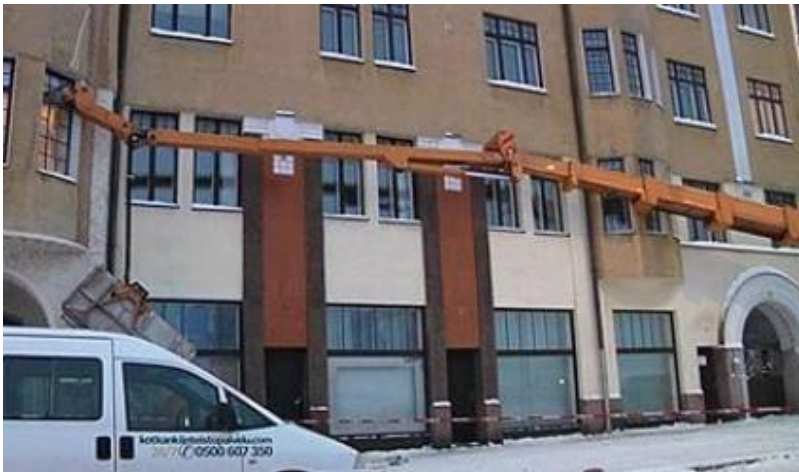
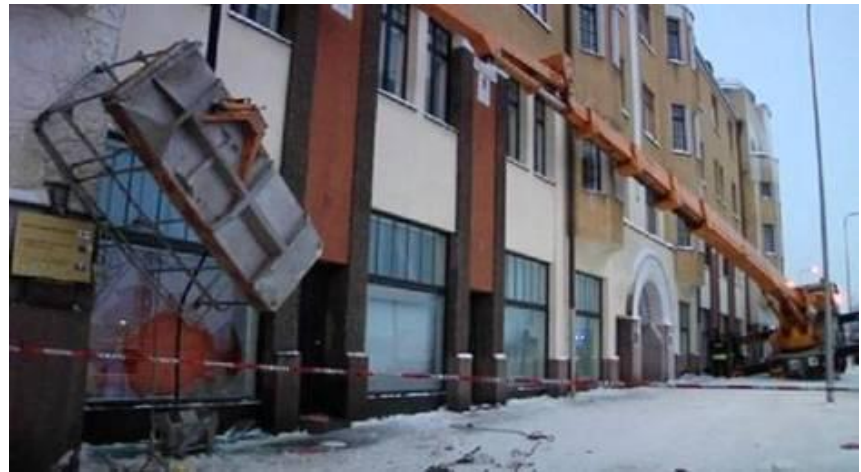
Support surface
collapsed under
outrigger.
2 fatalities.
Europe.

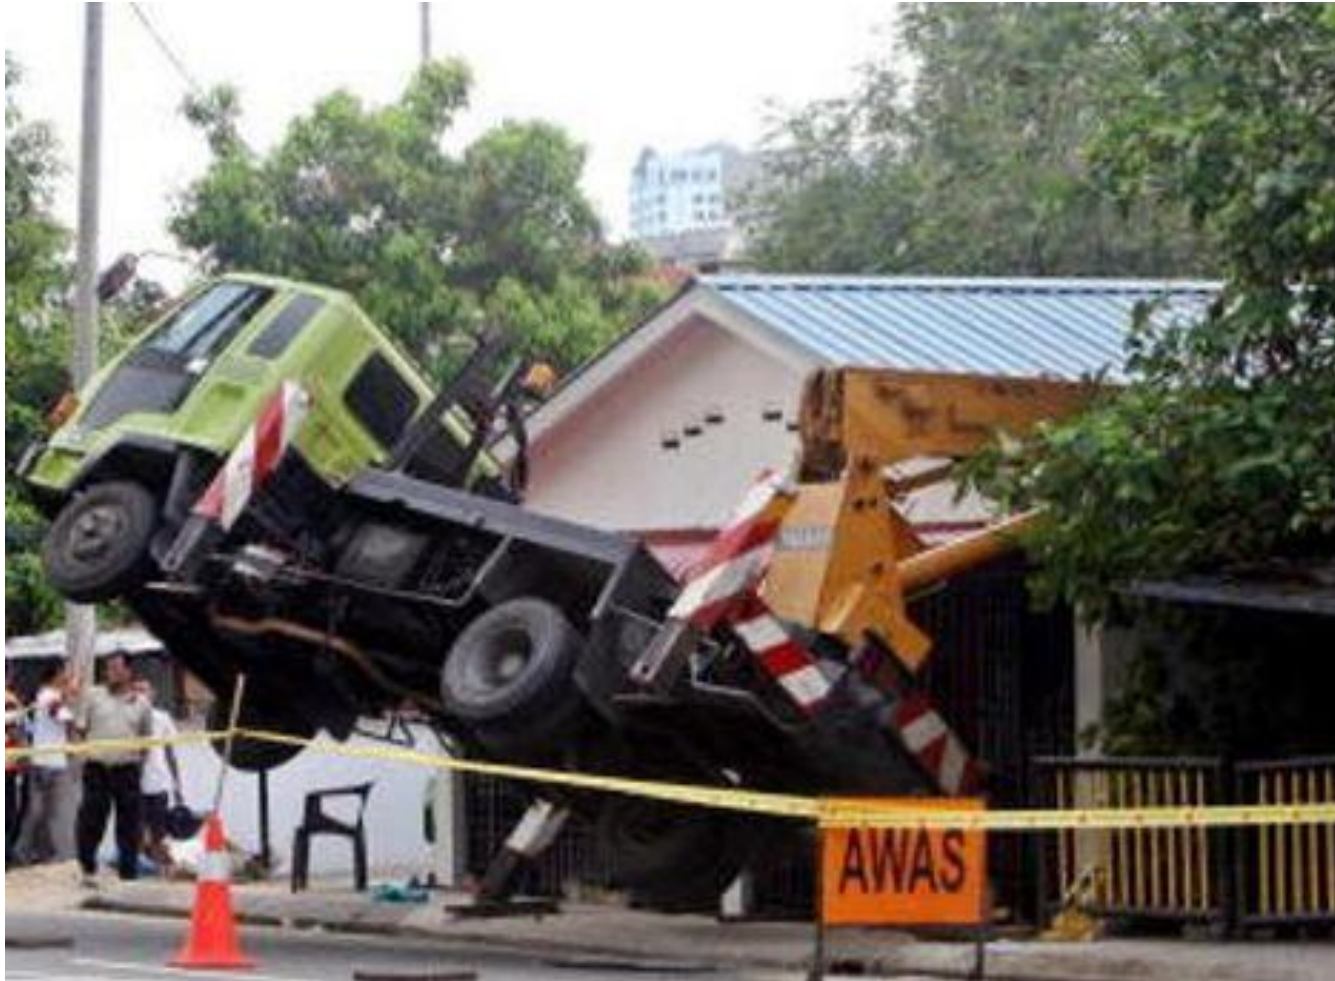
Soft ground under outrigger. Fatality. Asia.

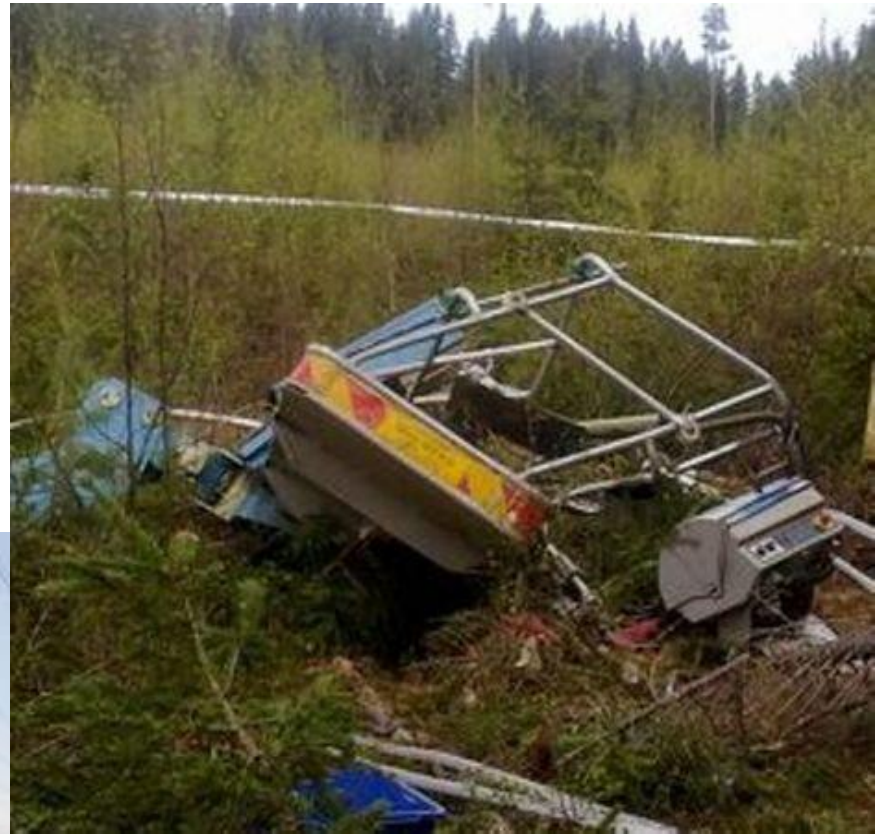
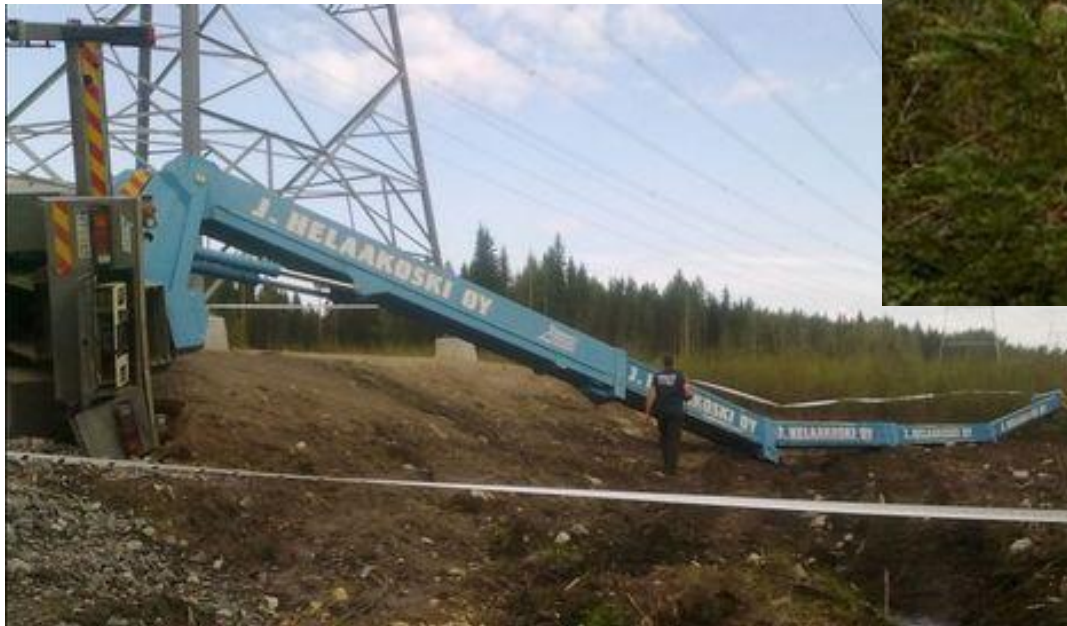
Soft ground under
outriggers. 3
injured. Europe.

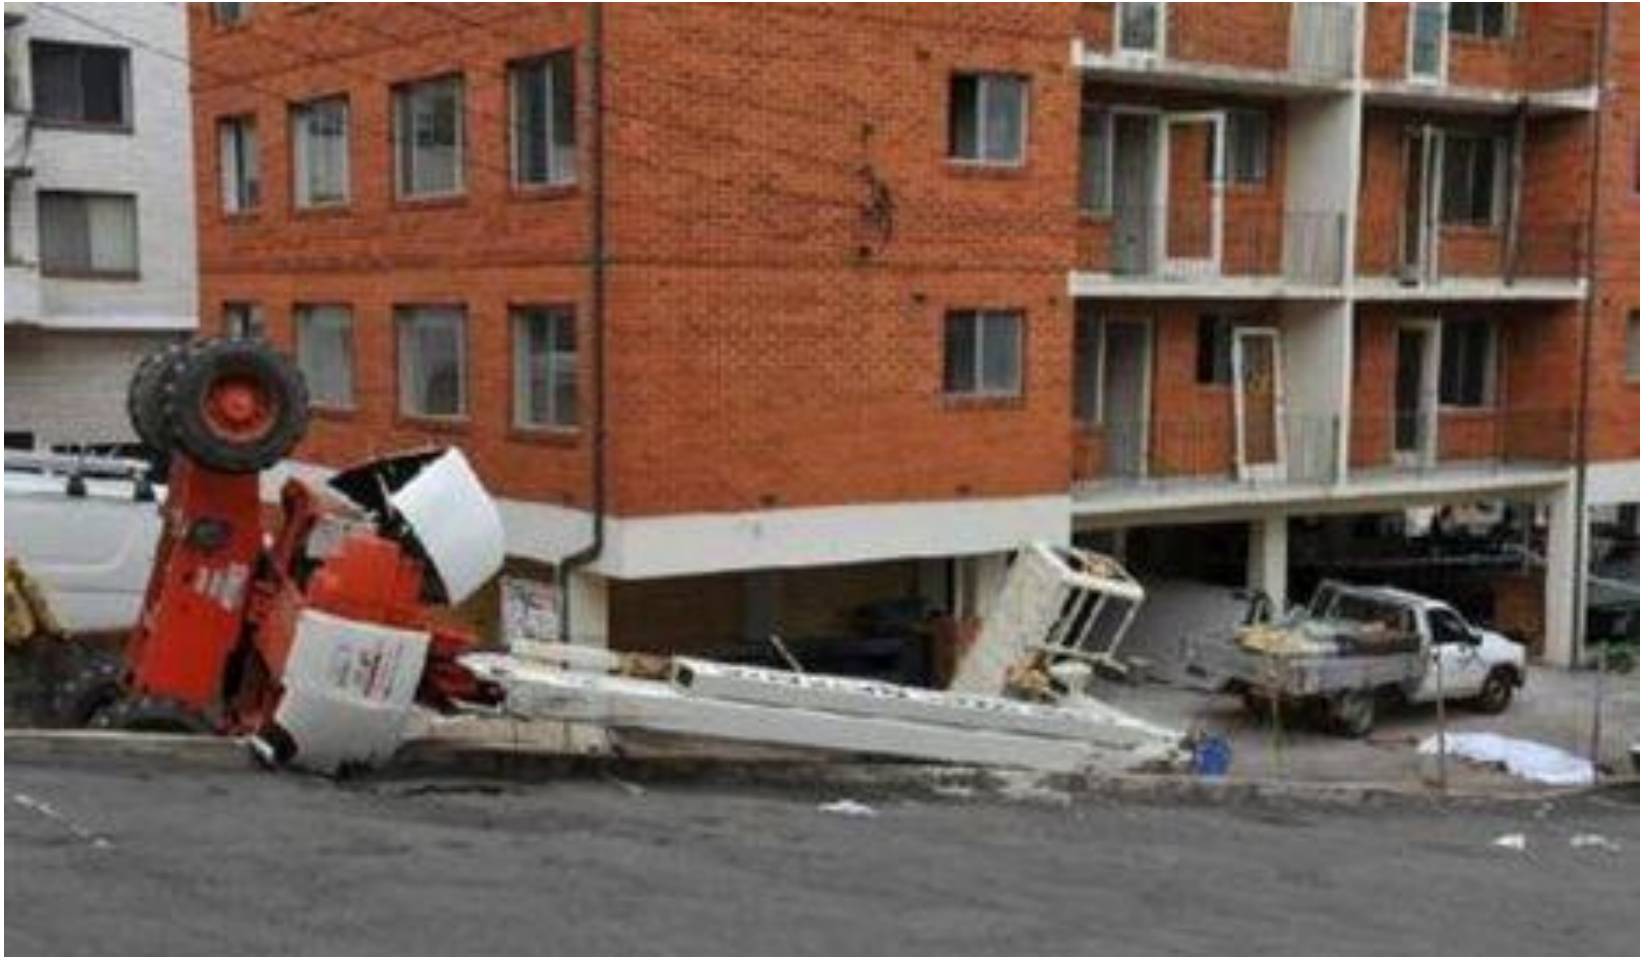
Excessive backward incline. Fatality. Australia.

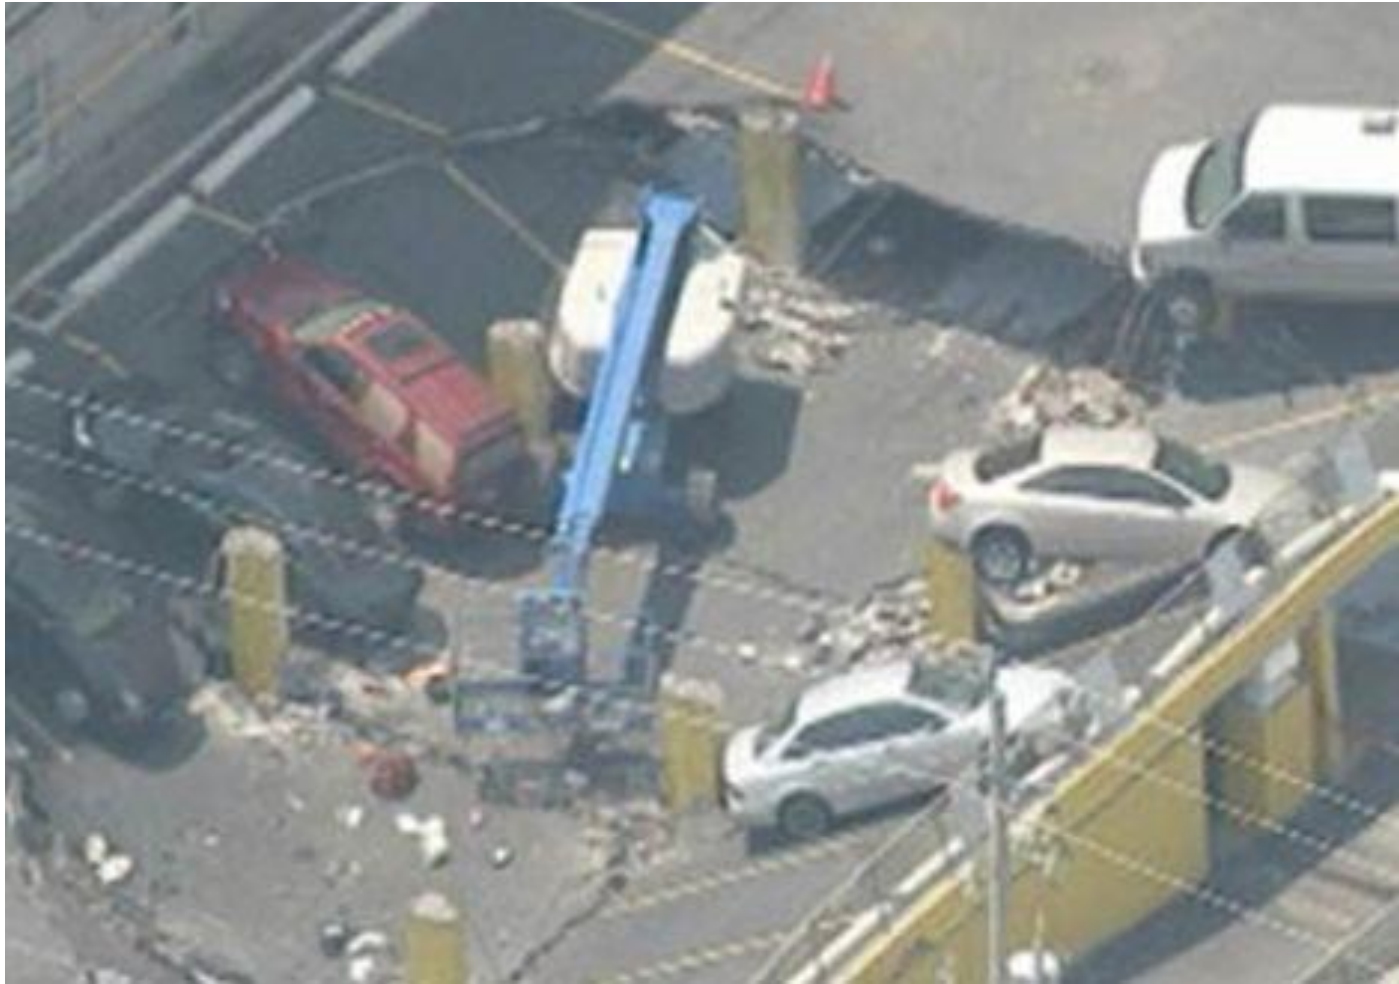
Floor load exceeded, structural collapse of carpark. USA.

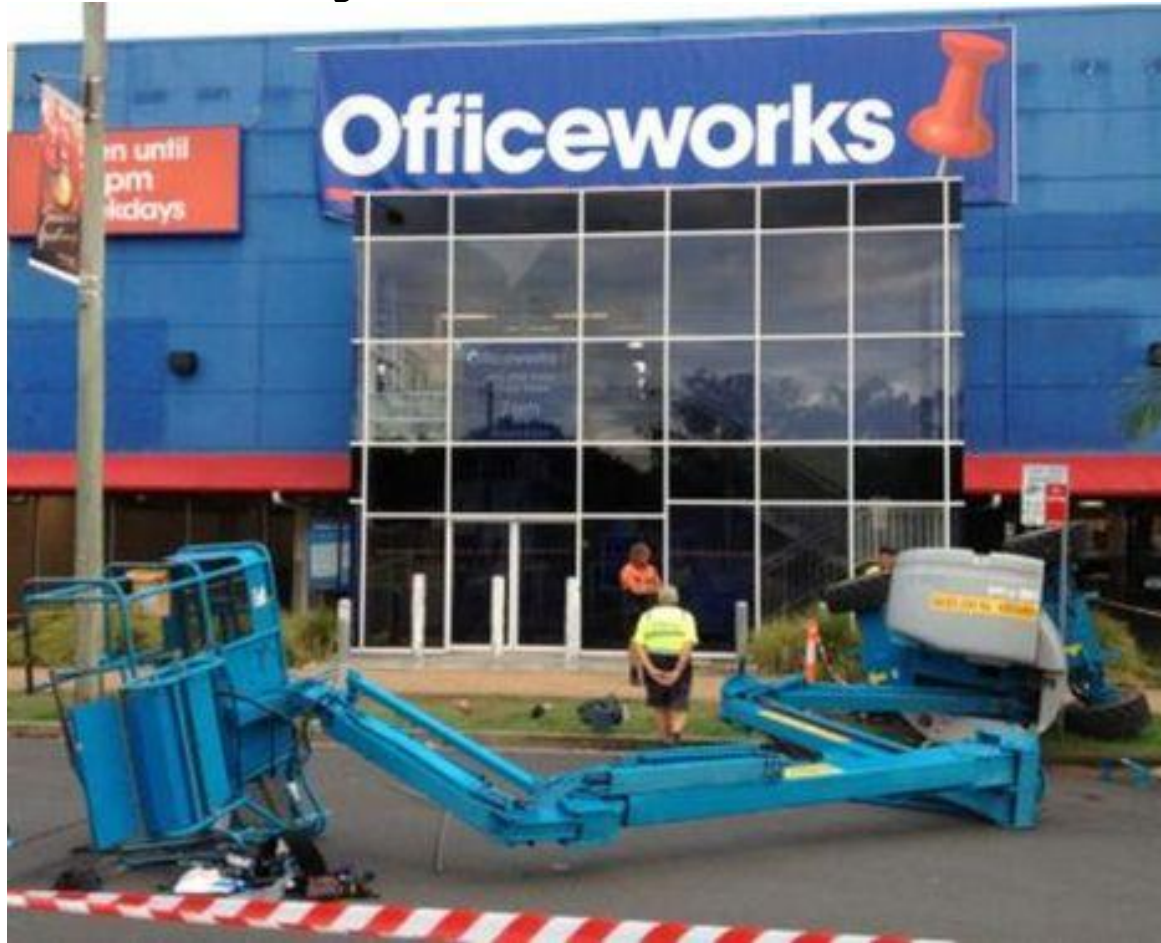
Wheel through steel grating. Two injured, Australia.

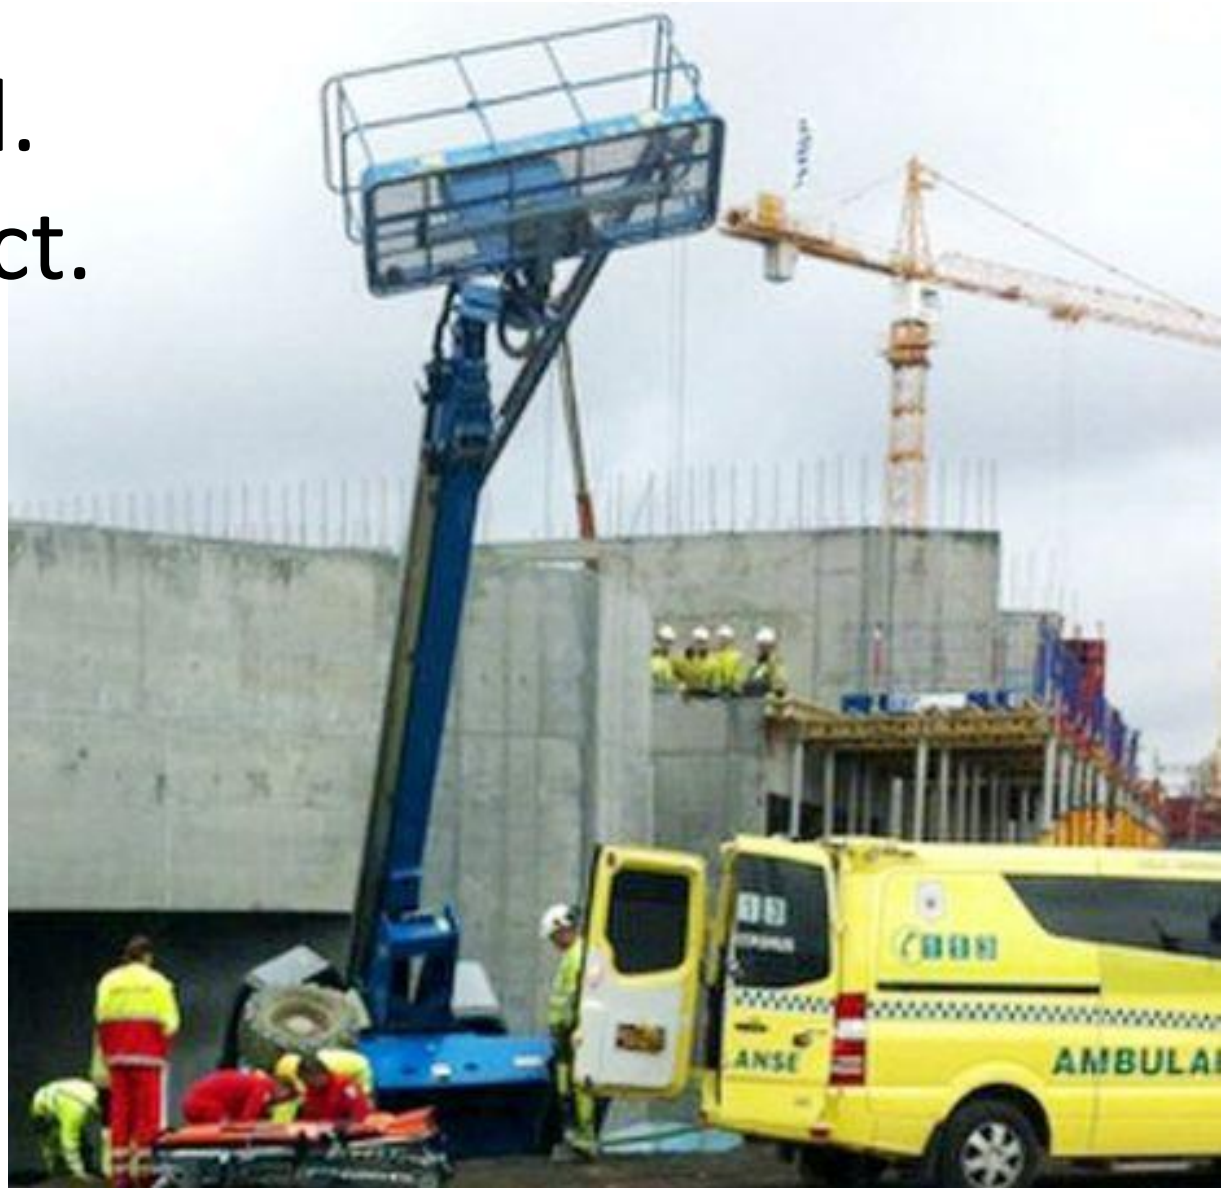
Soft Ground.
Catapult effect.
Injuries.
Europe.

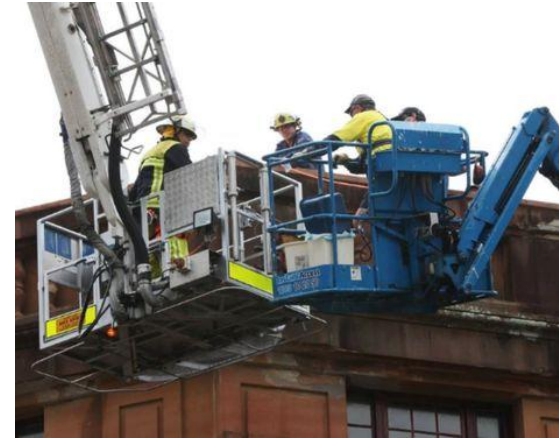
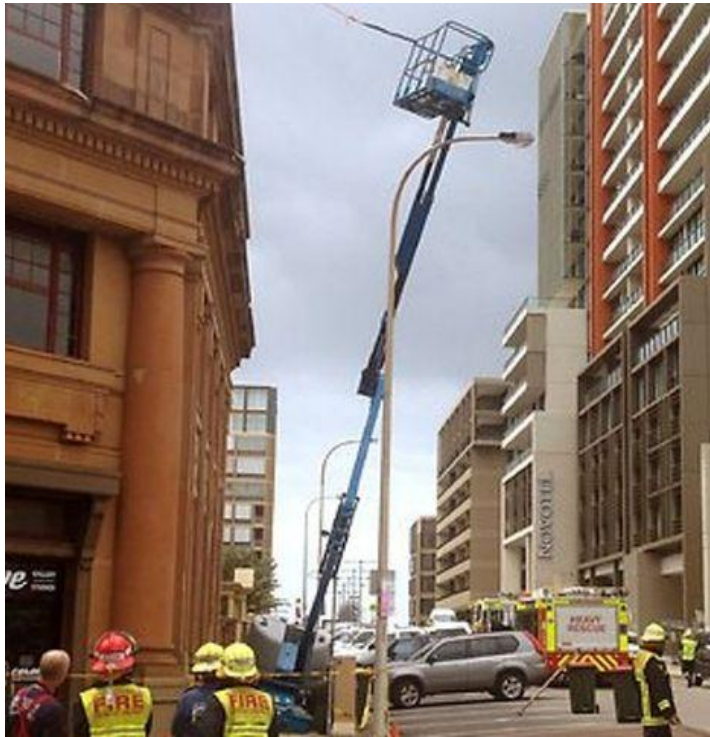
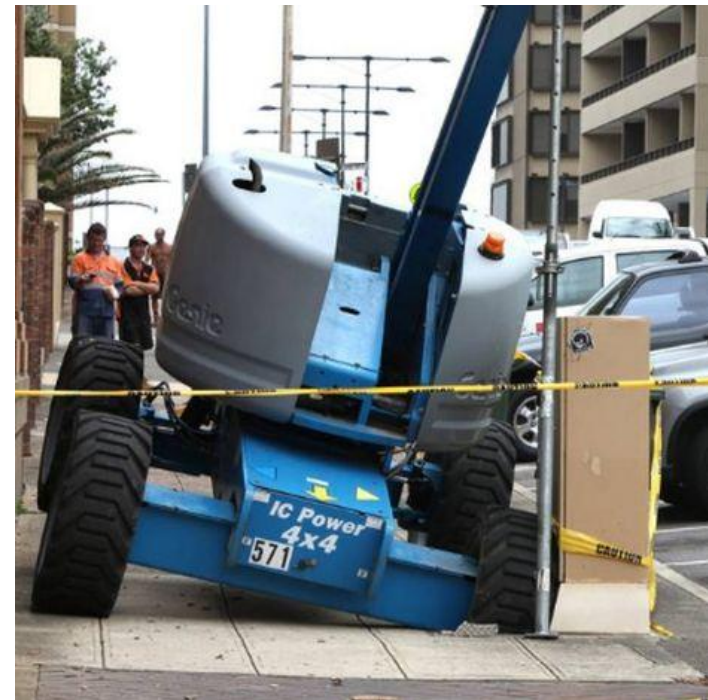
Culvert collapsed. Operators rescued. Australia.

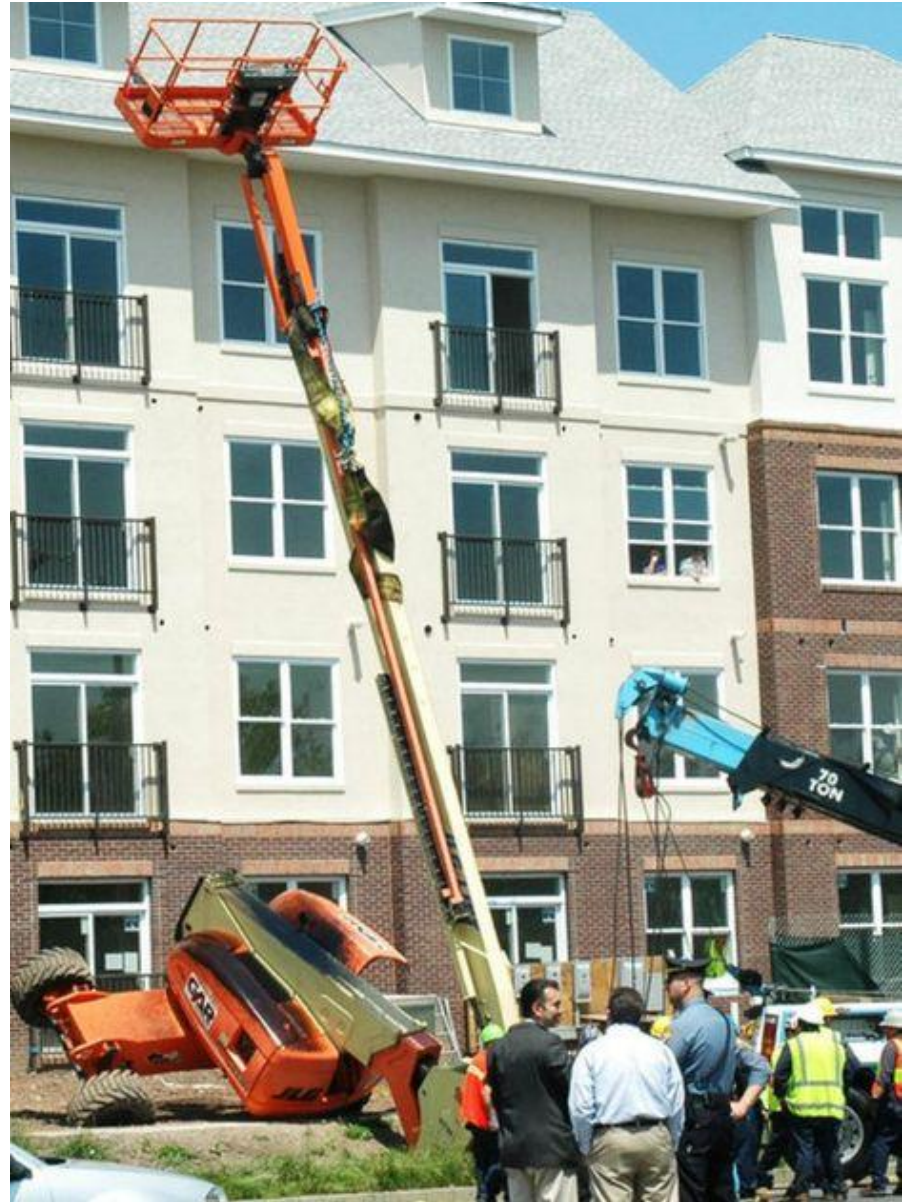
Soft ground. Catapult. Fatality USA.

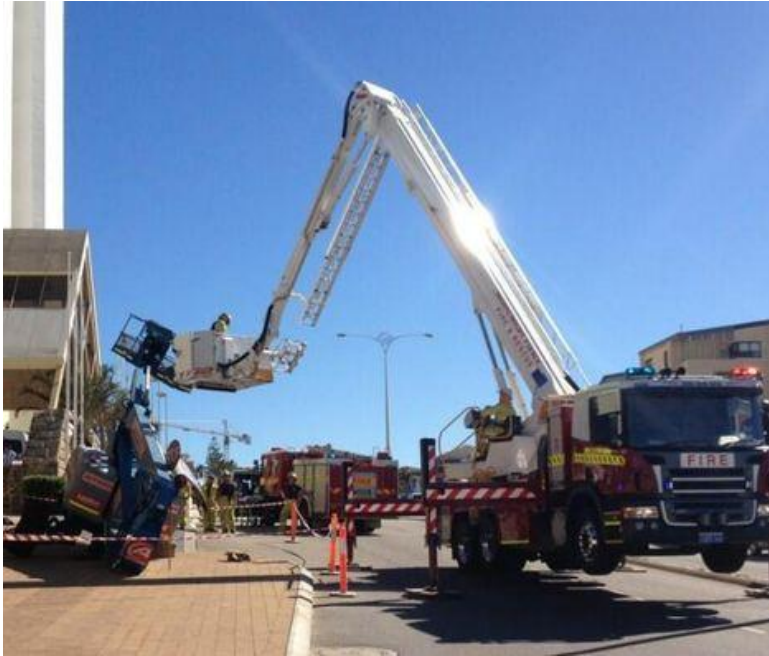
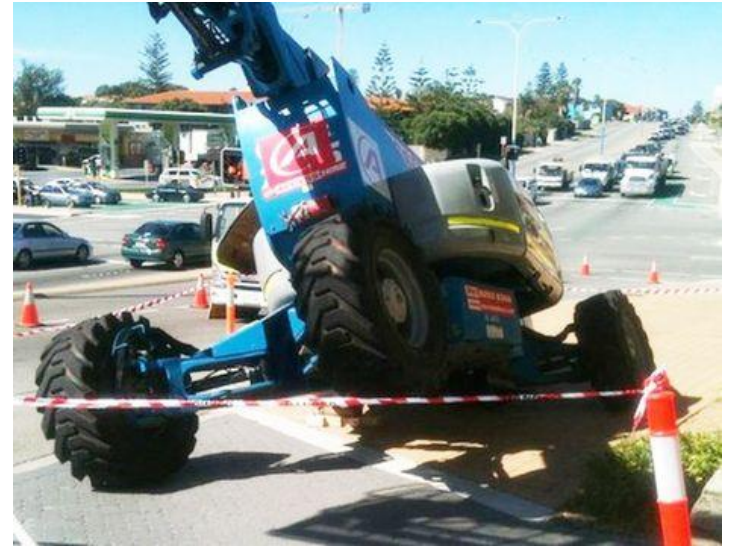
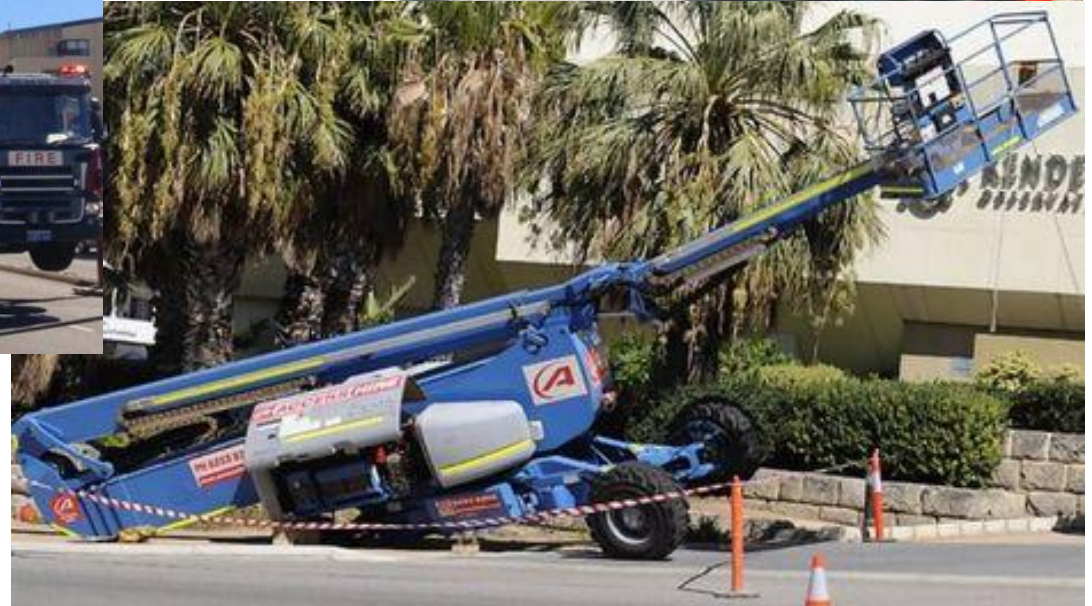
Unsupported surface, Electric culvert cover collapsed, operator rescued. Australia.
